# Manhole Inspection Summary

Manhole # S21M\_\_019MH

Insp Date: **3/21/08 10:55 AM**

**Location** Address: **1813 ramsay-wilkens alley**

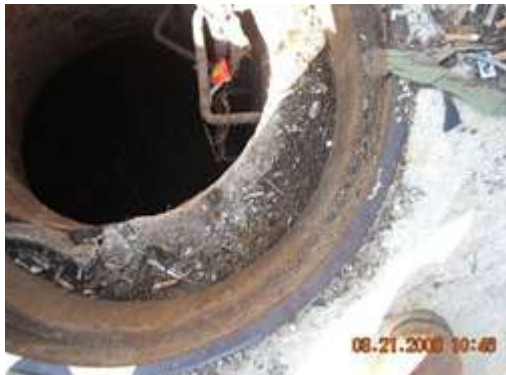
Defect 1

Offset: **4** (in.)

frame offset

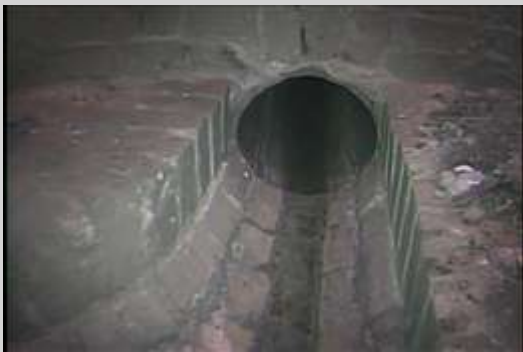
12 O'Clock Outflow

8 in. Circular Gravity Sewer  
Pipe Out @ 12 O'Clock

Deposits: ☒ None ☐ Mud ☐ Sludge ☐ Debris ☐ Grease

Infiltration: **None** Pipe Seal Cond: **Sound**

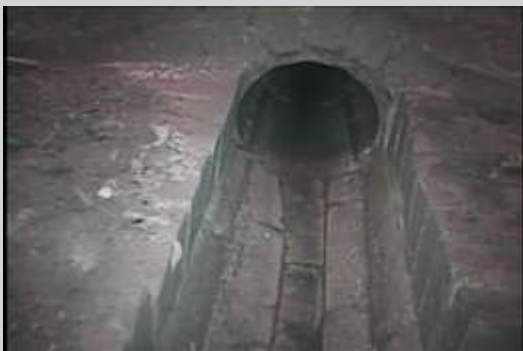
6 O'Clock Inflow

8 in. Circular Gravity Sewer  
Pipe In @ 6 O'Clock

Deposits: ☒ None ☐ Mud ☐ Sludge ☐ Debris ☐ Grease

Infiltration: **None** Pipe Seal Cond: **Sound**

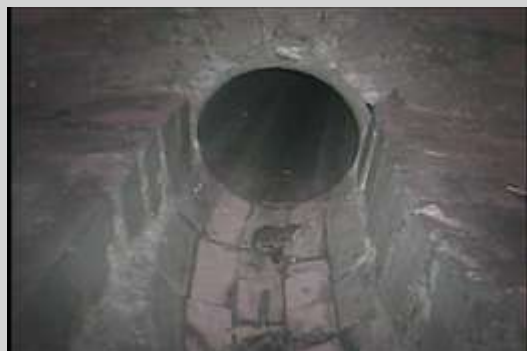
9 O'Clock Inflow

8 in. Circular Gravity Sewer

Pipe In @ 9 O'Clock

Deposits: ☒ None ☐ Mud ☐ Sludge ☐ Debris ☐ Grease

Infiltration: **None** Pipe Seal Cond: **Sound**
